Clearview Landfill Community Update

Lower Darby Creek Area Superfund Site

September 30, 2020

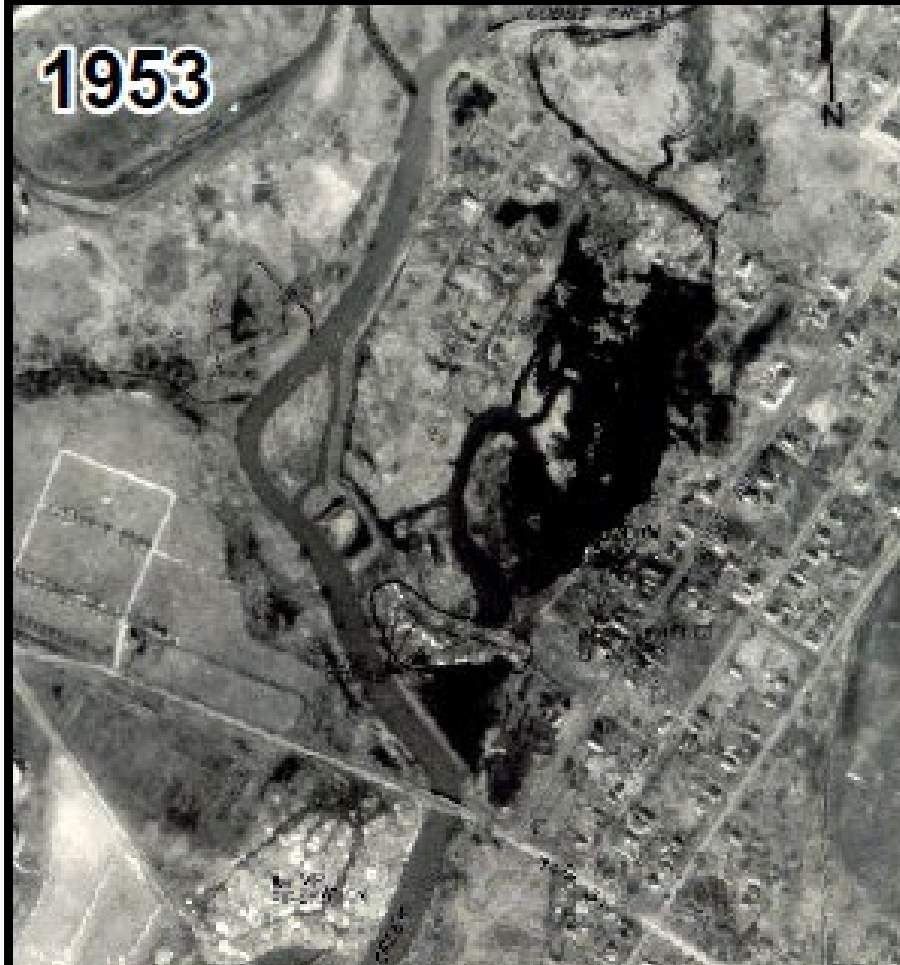
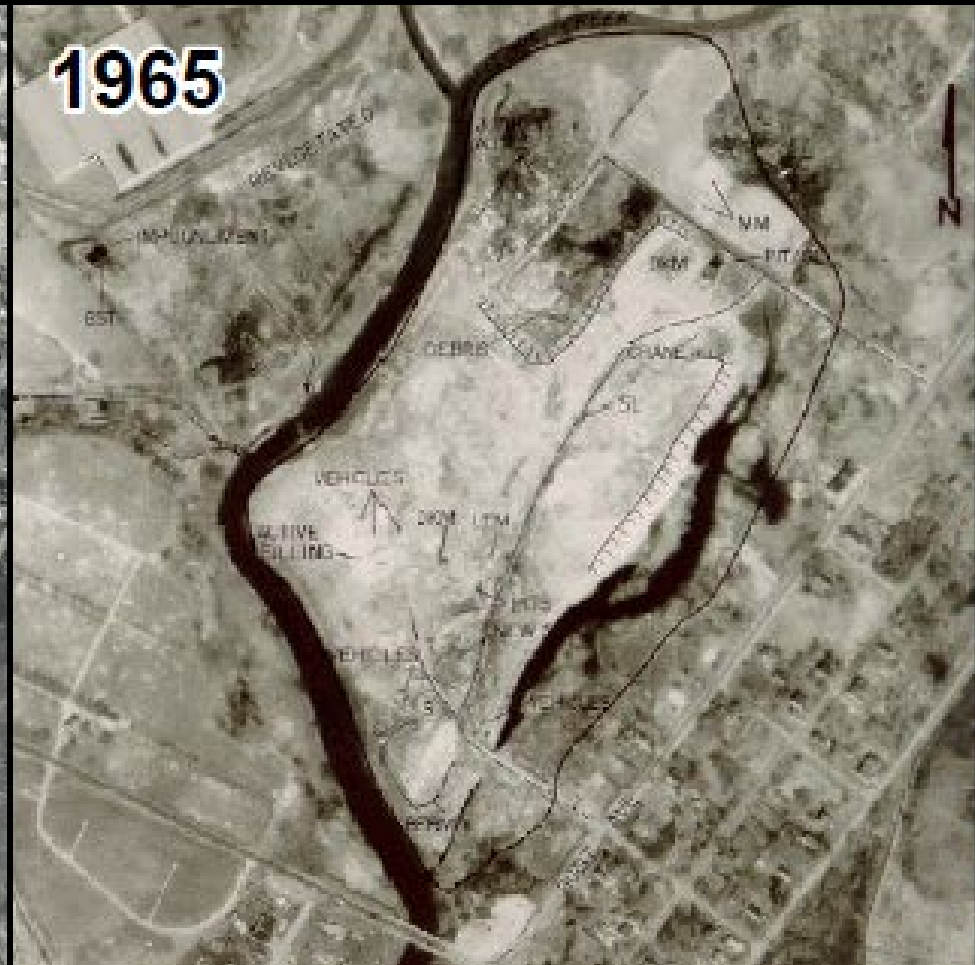
Historic Wetland Filling At Clearview Landfill

1953

1965

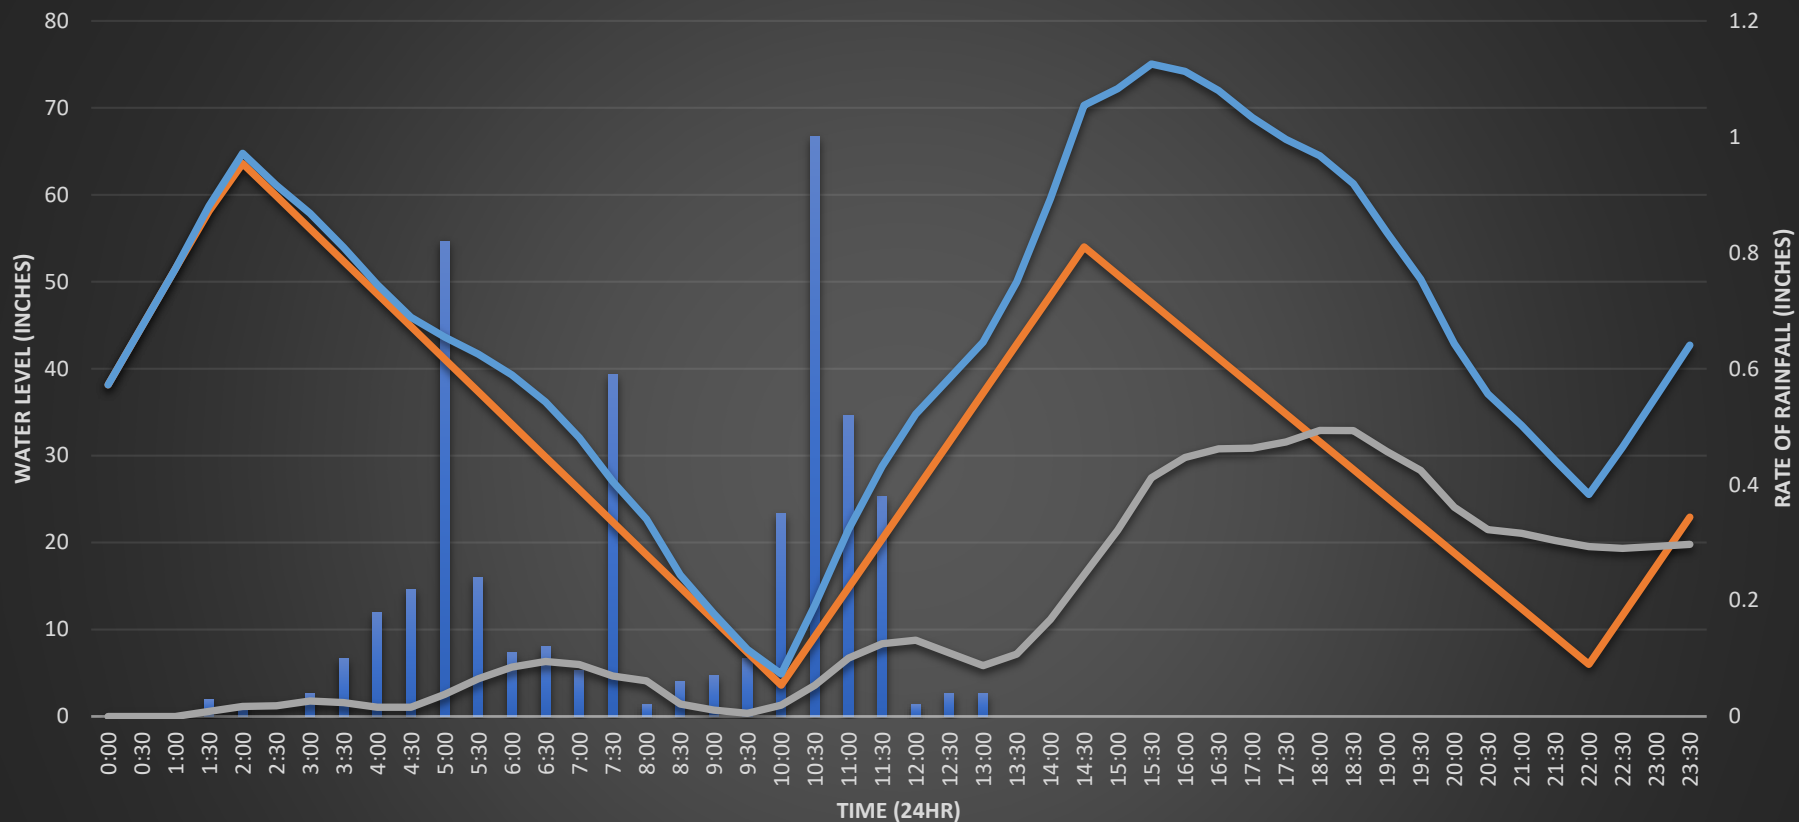
Storm Surge & Precipitation

08/04/2020 - Isaias Impact at Clearview Landfill

DATA SOURCES: PRECIPITATION - TETRA TECH CLEARVIEW LANDFILL WEATHER STATION, PREDICTED TIDE - TINICUM NATIONAL WILDLIFE REFUGE, DARBY CREEK, PA, STORM SURGE - NOAA TIDES AND CURRENTS (MARCUS HOOK, PA)

■ Precipitation ■ Predicted Tide ■ Storm Surge ■ Storm Surge + Predicted Tide

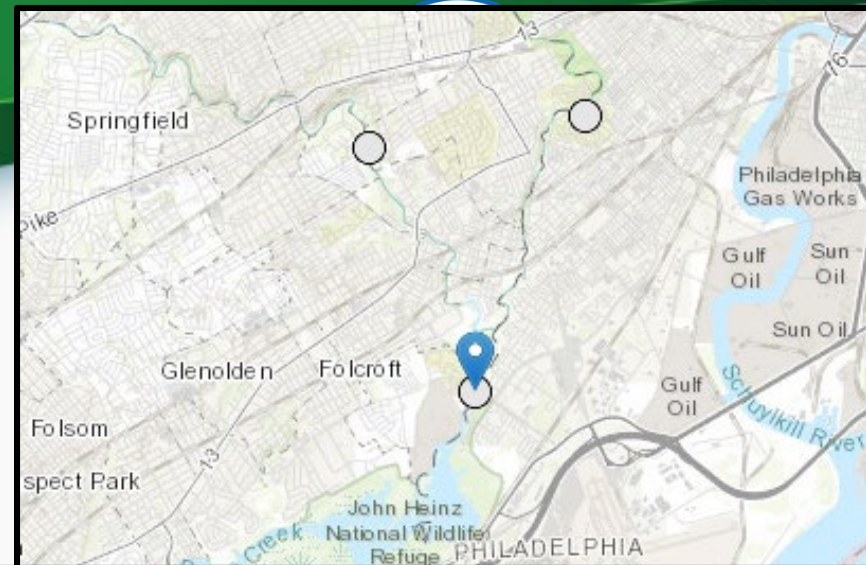
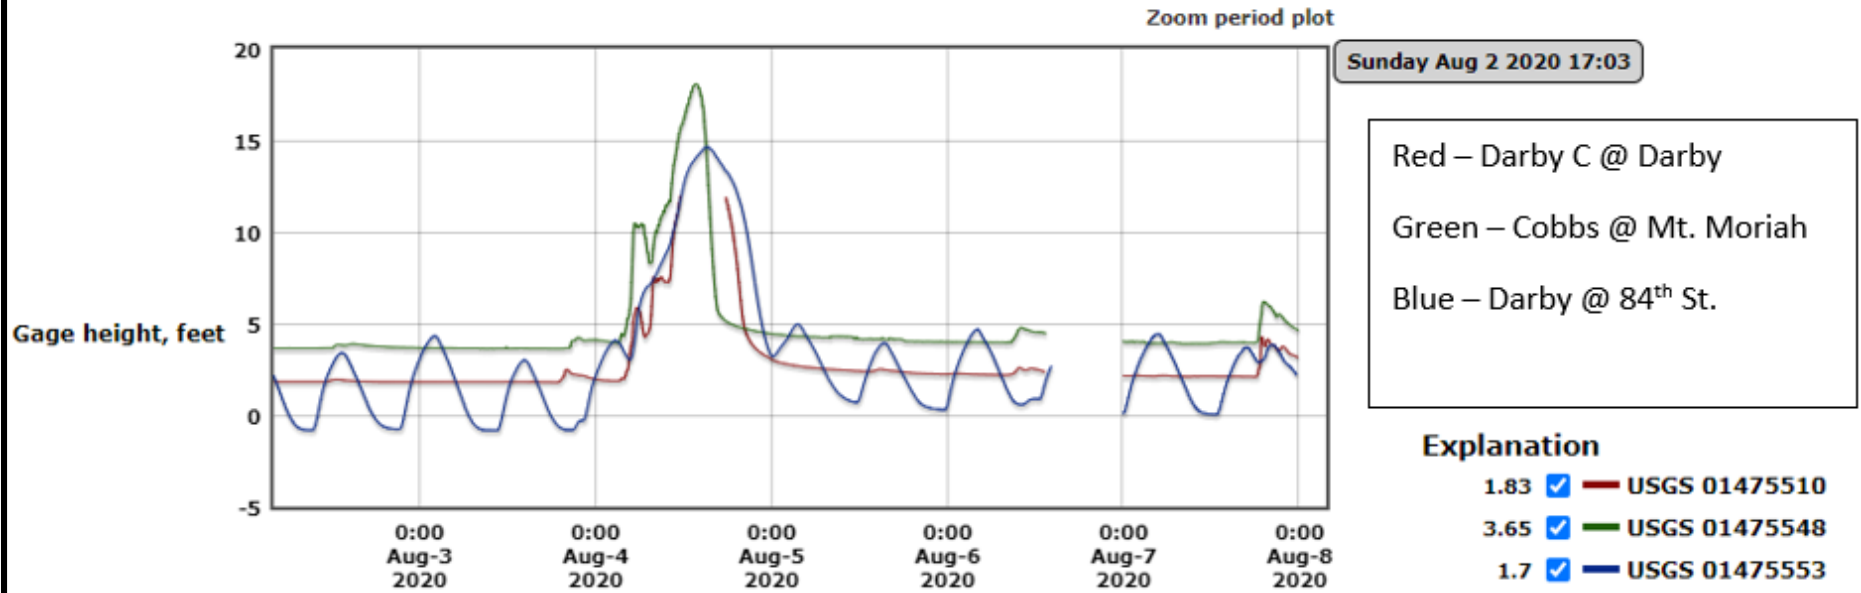
Stream Gauge Height

USGS 01475510 Darby Creek near Darby, PA
USGS 01475548 Cobbs Creek at Mt. Moriah Cemetery, Philadelphia
USGS 01475553 Darby Creek at 84th St Bridge at Eastwick, PA

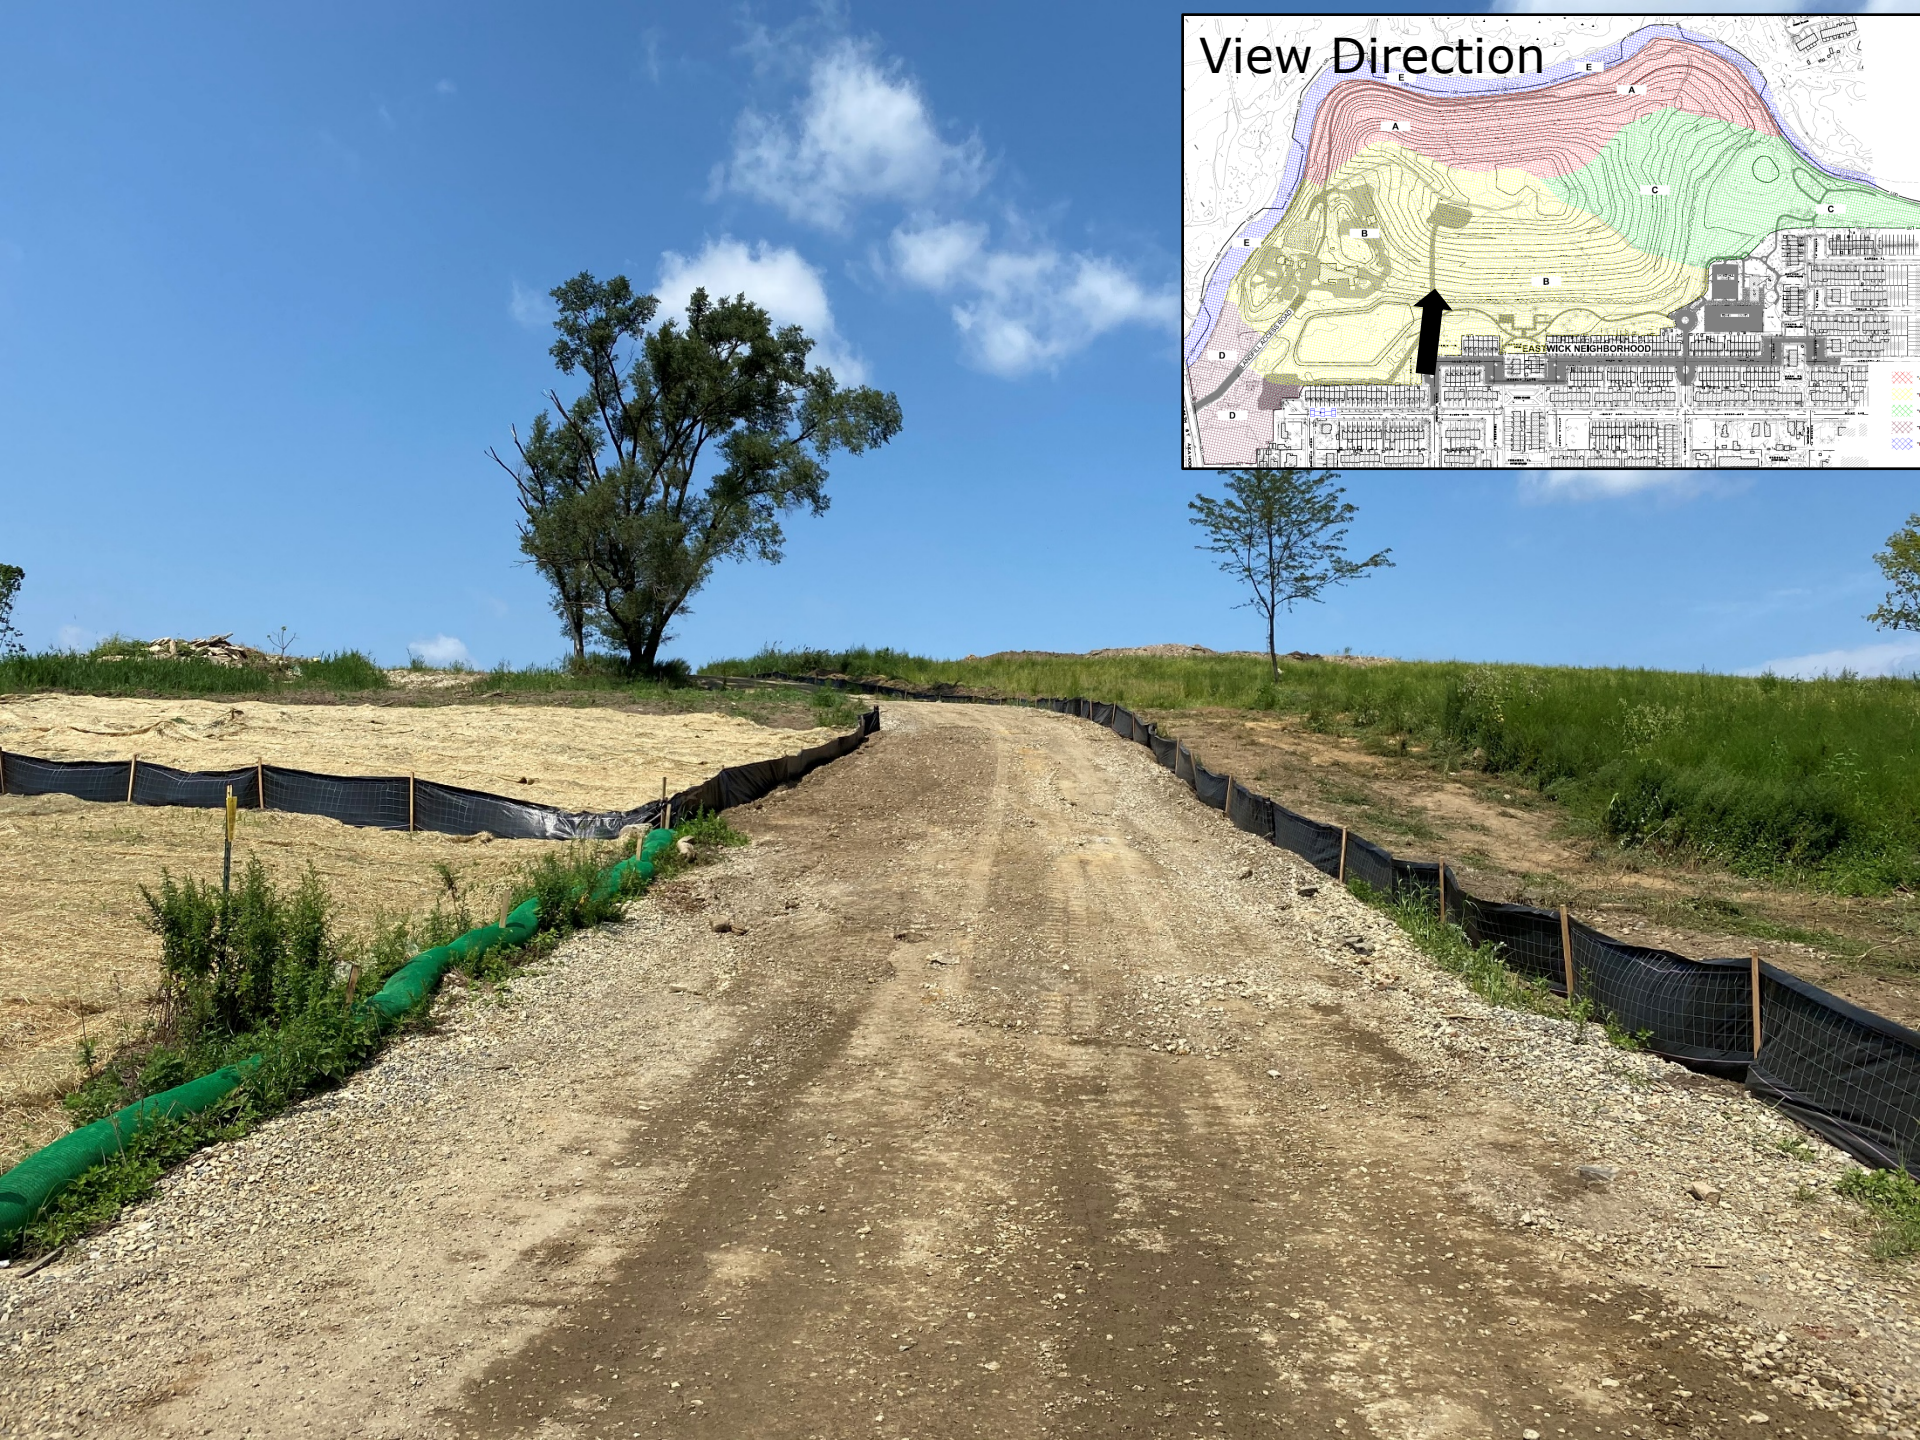
LDCA
FLOODING

Washout - Access
Road

8/4/2020

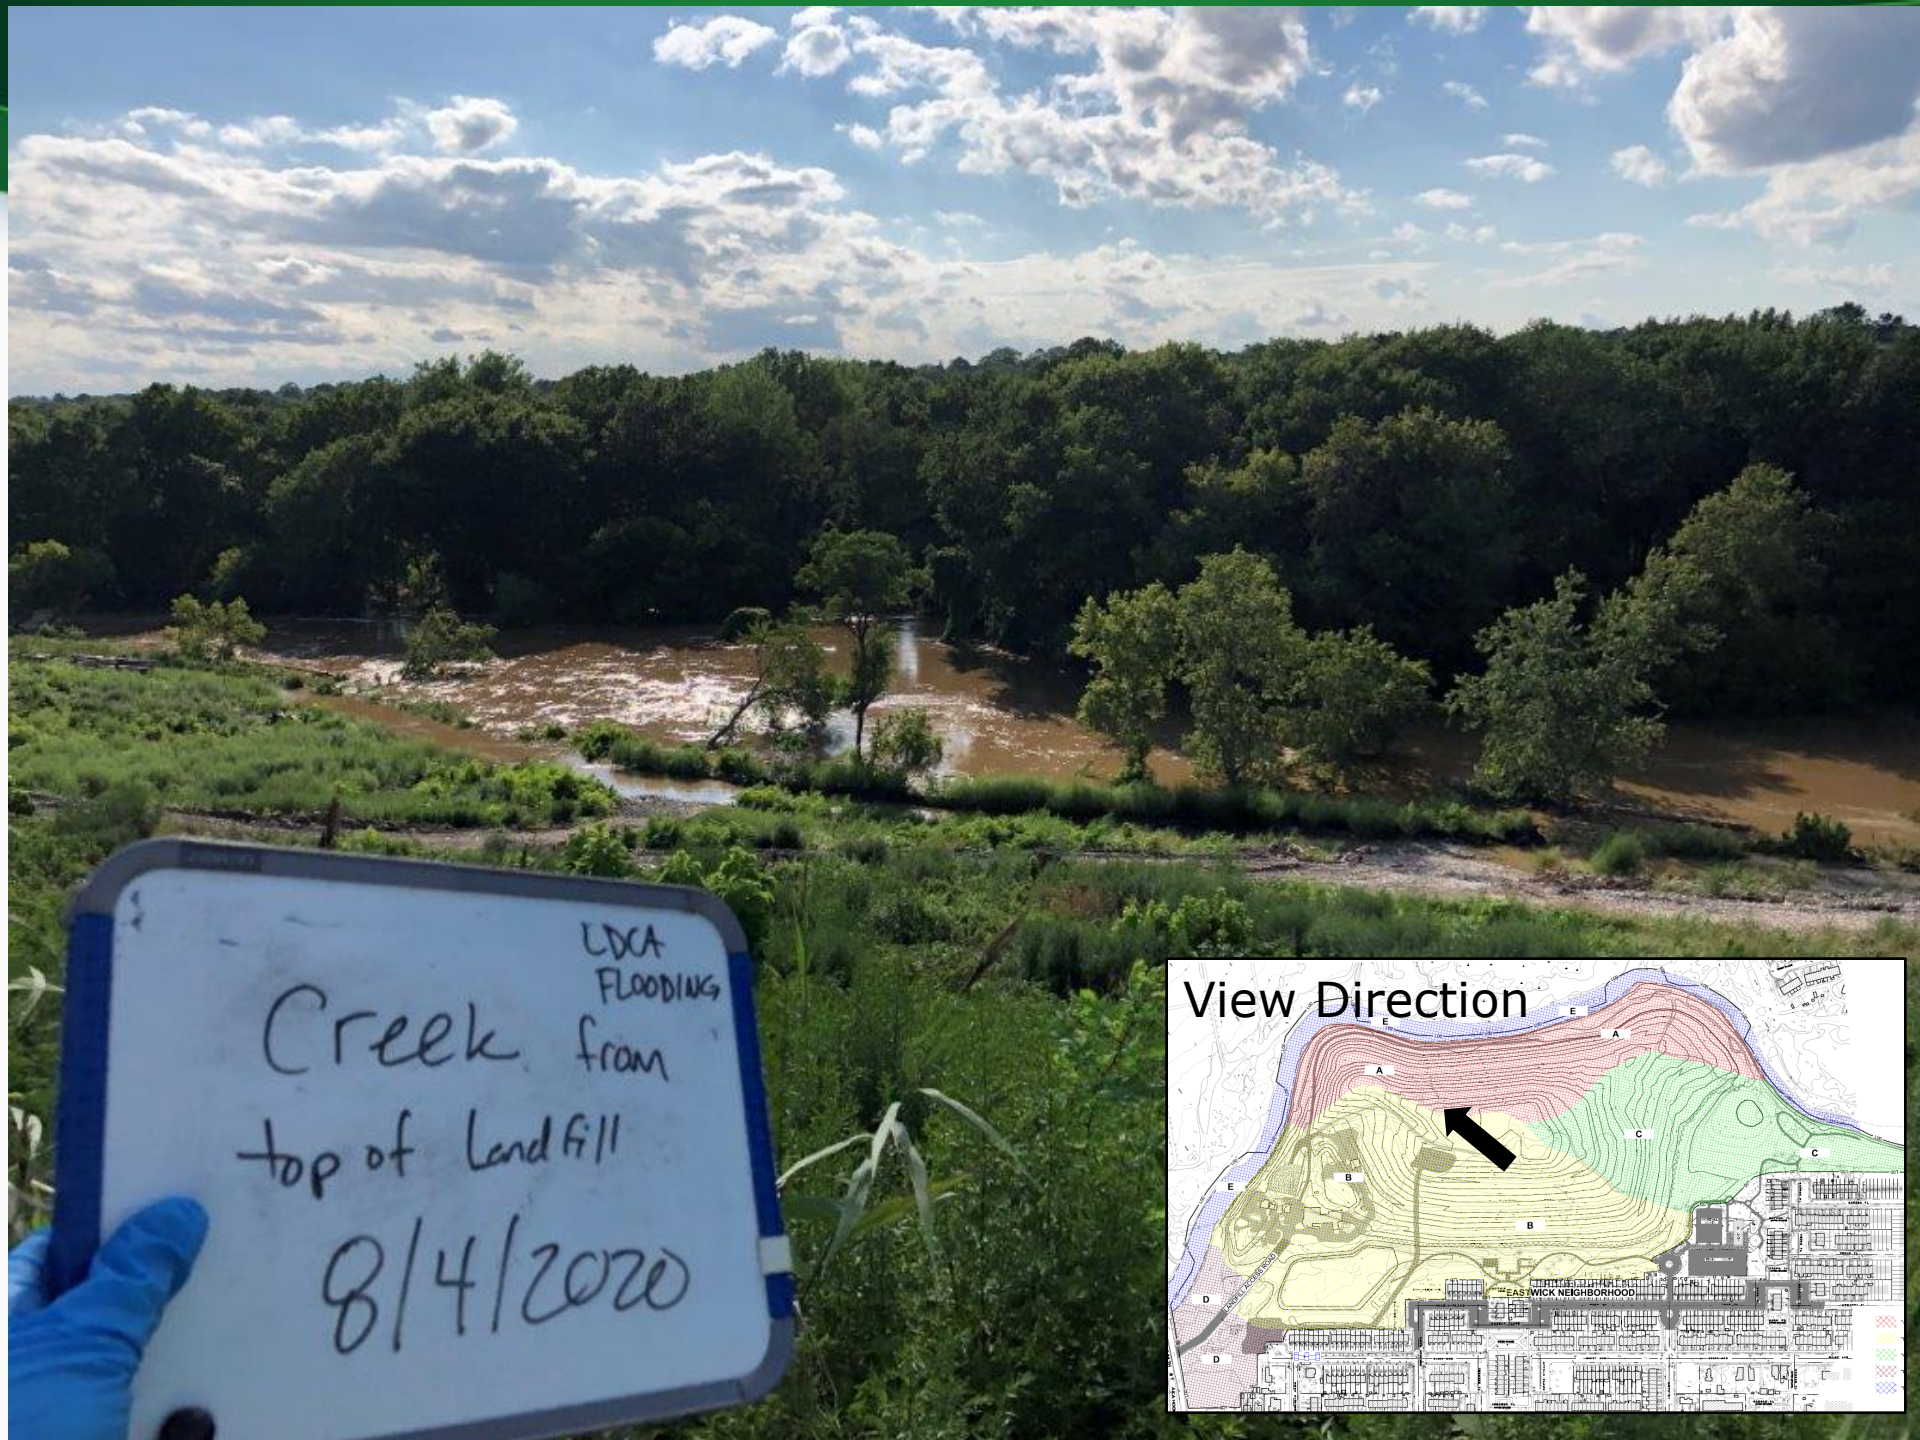
LDCA
FLOODING

Creek from
top of Landfill

8/4/2020
