Former Haverford State Hospital

ECOLOGICAL ASSESSMENT

December 2008

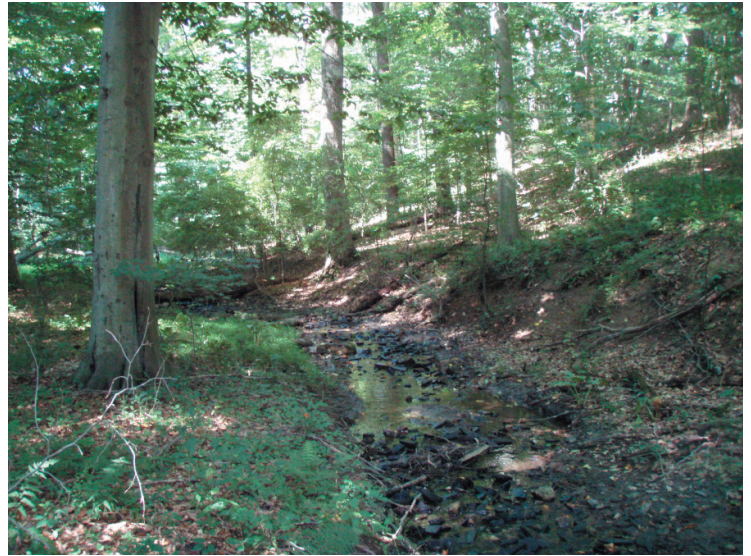
PHOTO 1: North Brook surrounded by red oak–mixed hardwood forest. August 2008.

The subject property is located in the higher elevations of the Darby Creek Watershed within the Delaware River Basin. Two spring-fed first order tributaries, North Brook (*Photo 1*) and South Brook, form their own subwatersheds on the site, feeding into Darby Creek (*Photo 2*) west and east of Route 476, respectively (see **Map 3: Hydrologic Features**). Base flows of these perennial streams are maintained by springs, seeps, and depressional wetlands along their course through the property (*Photo 3, page 4*). North

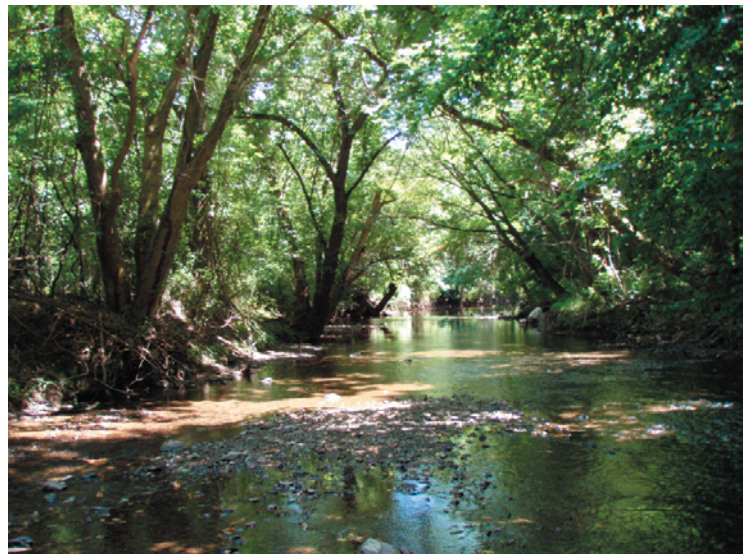
PHOTO 2: Darby Creek and surrounding floodplain forest. August 2008.

The reliable, deep, swift base flow of Darby Creek offers an attractive habitat for aquatic birds (*Photo 2, page 3*). In contrast, the North and South Brooks provide more shallow stream flows (*Photo 19, page 16*). Specifically, the Spotted sandpiper, Great blue heron, Mallard duck, and Belted kingfisher were all observed on Darby Creek. Northern rough-winged swallows were observed nesting in the far bank of Darby Creek, and Cedar waxwings and Blue-gray gnatcatchers were observed in the sycamores along the riparian corridor.

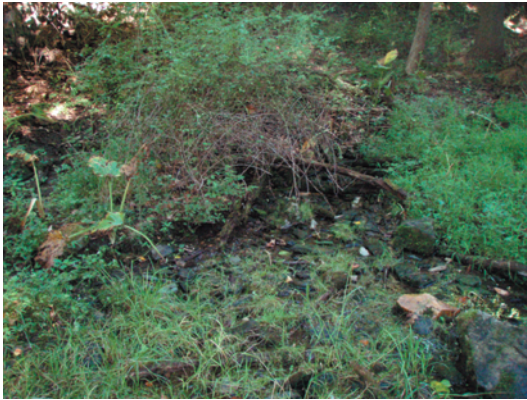
Brook is obstructed by an undersized steel culvert that retards storm flows; a marsh has developed upstream of the culvert and moved the confluence of two feeder streams downstream to just above the culvert. Further downstream, North Brook travels under Route 476 through a five-foot diameter concrete culvert. Vernal (seasonal) pools occur in and near the floodplain forest west of Route 476 (*Photos 4 and 5*).

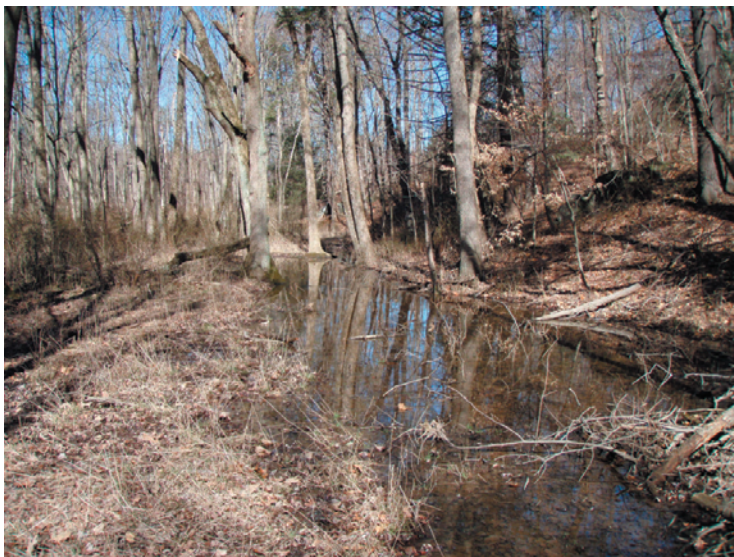
PHOTO 4: Vernal pool in Darby Creek section. March 2008.

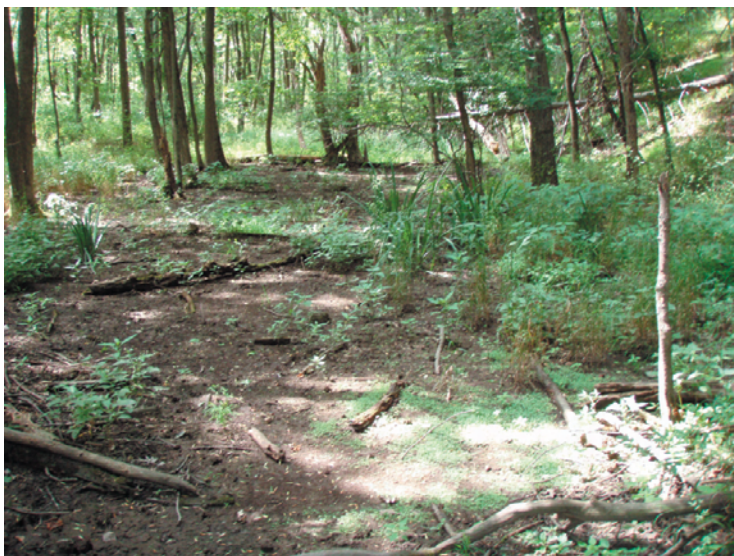
PHOTO 5: Vernal pool in Darby Creek section. August 2008.

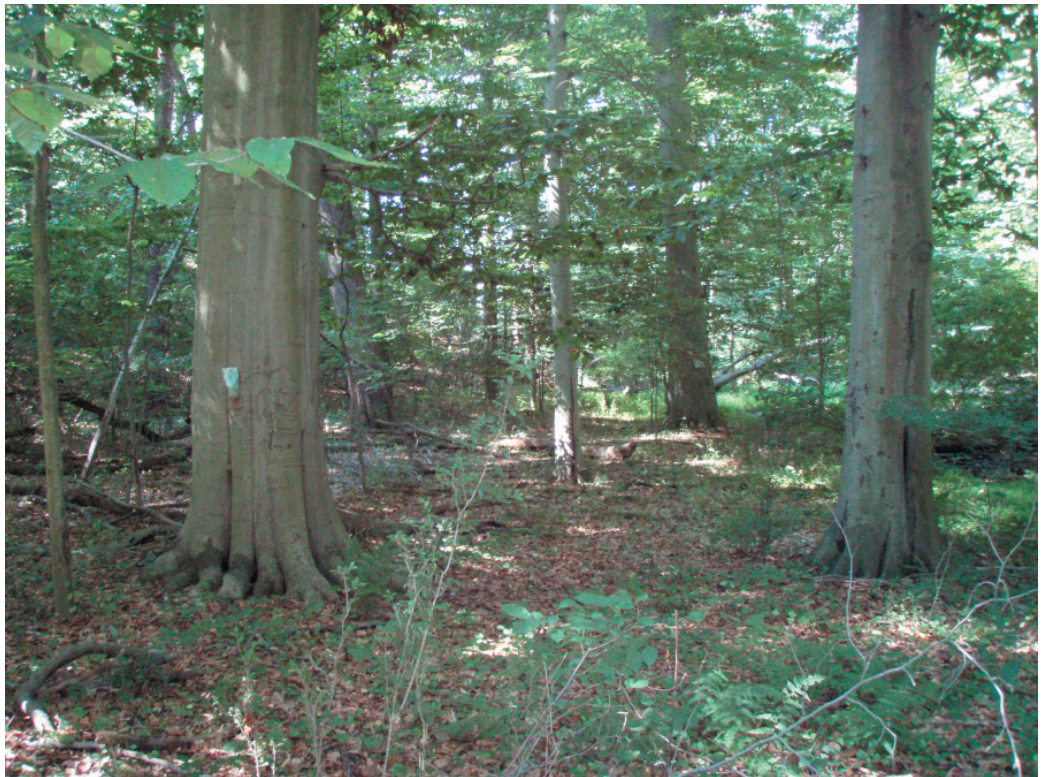
PHOTO 6: Red oak mixed hardwood / tuliptree-beech-maple forest. August 2008.

1. Red oak–mixed hardwood/tuliptree–beech–maple forest (29.9 acres). This forest is a mix of the two communities that are the most common forest types in our region. Dominant canopy species include red and black oak (*Quercus rubra*, *Q. velutina*), with tuliptree (*Liriodendron tulipifera*), beech (*Fagus grandifolia*), sugar maple (*Acer saccharum*), and hickories (*Carya* spp.). Sugar maple is frequent in the understory and spicebush (*Lindera benzoin*) dominates the shrub layer (Photo 6). This forest is the oldest on the property, as indicated by patches of mature forest in the same locations on **Map 7: Historical Aerial Photography 1937** and, as a result, is least impacted by exotic invasive plant species. This community buffers North Brook and South Brook and is critical to the protection of water quantity (forests maximize water infiltration that helps ensure perennial flow from seeps and springs) and quality (through shading and the contribution of organic matter to support aquatic biota).

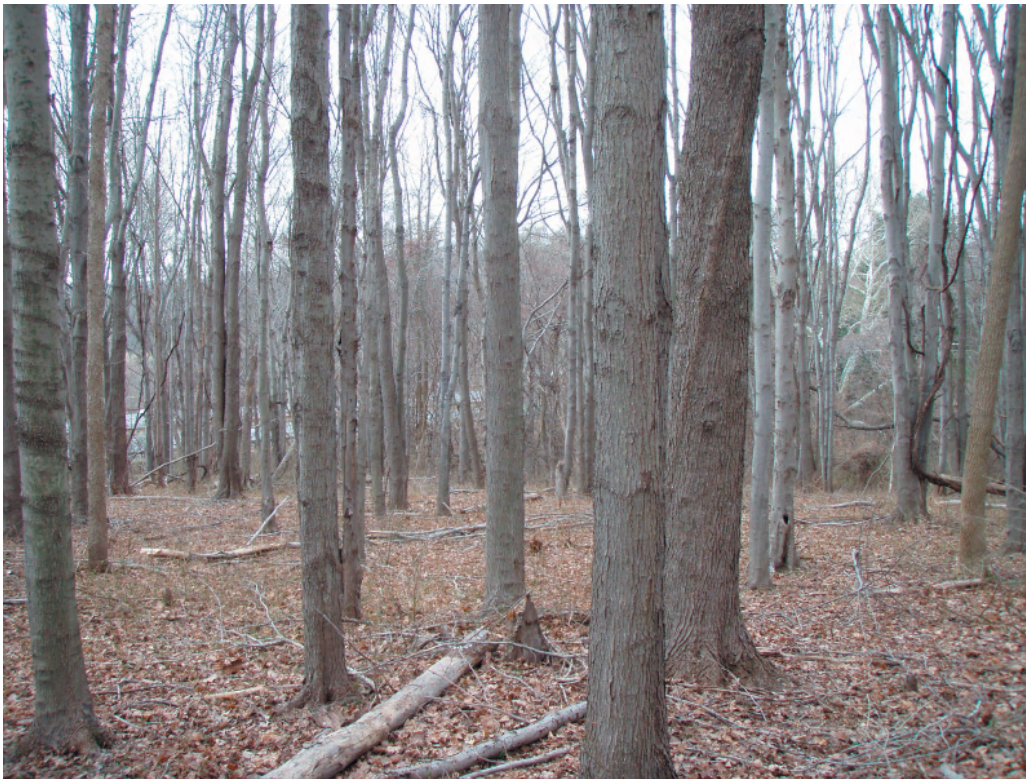
PHOTO 7: Red maple terrestrial forest. January 2008.

This forest is the most extensive plant community on the site and covers large swaths of the North Brook and South Brook watersheds on the property. Dominant canopy species include red maple (*Acer rubrum*), red ash (*Fraxinus pennsylvanica*), black cherry (*Prunus serotina*) and tuliptree, with red ash, tuliptree, red maple, and hickories in the understory (Photo 7). In and around the old field/terrestrial meadow in the middle of the northern block of this forest, we found a variation of the red maple terrestrial forest containing Scots pine (*Pinus sylvestris*), white pine (*Pinus strobus*), big-tooth aspen (*Populus grandidentata*), crabapple (*Malus* sp.), and black locust (*Robinia pseudoacacia*). This red maple terrestrial forest ranges in age from approximately 20 to 60 years and, overall, is moderately impacted by invasive plants including multiflora rose (*Rosa multiflora*), oriental bittersweet (*Celastrus orbiculatus*), and Japanese corktree (*Phellodendron amurense*).

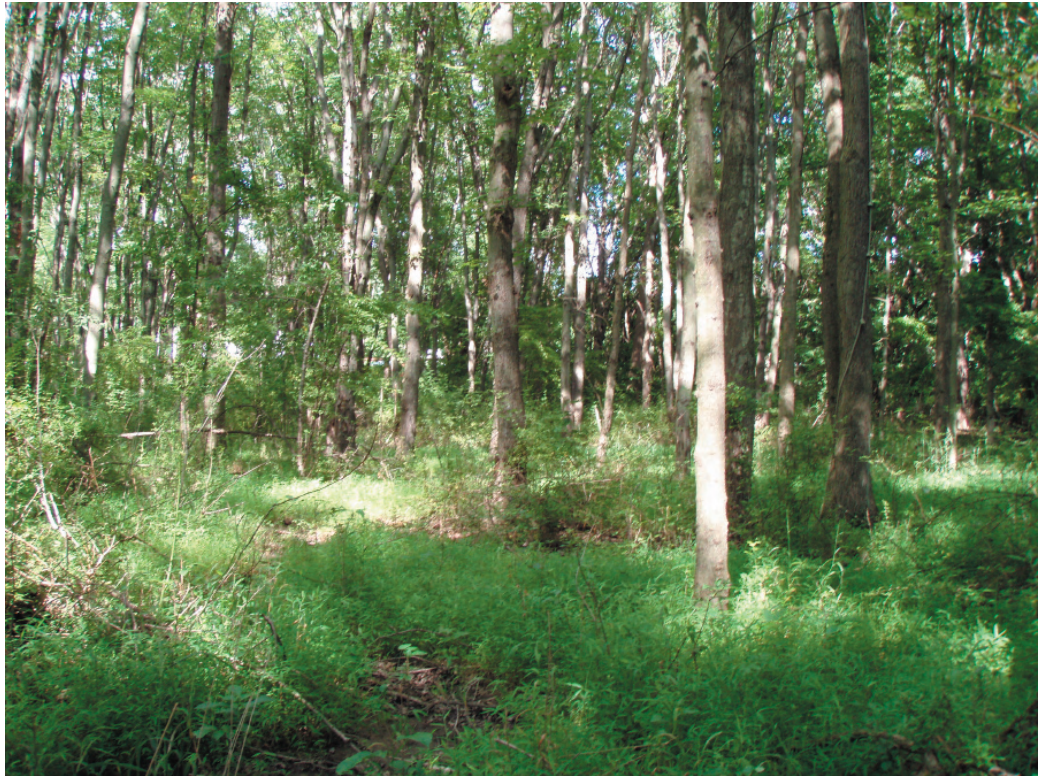
**PHOTO 8: Red maple
palustrine forest.
August 2008.**

This wetland forest covers the northern extent of the parcel west of Route 476 and is dominated by red maple and red ash in the overstory, with less frequent pin oak (*Quercus palustris*), shagbark hickory (*Carya ovata*), and black cherry (Photo 8). Understory trees include box-elder (*Acer negundo*) and black walnut (*Juglans nigra*). Several species of invasive plants are moderately impacting the shrub layer of this forest, including multiflora rose, Japanese honeysuckle (*Lonicera japonica*), and privet (*Ligustrum vulgare*). The red maple palustrine forest is similar in age (20–60 years) to its terrestrial version.

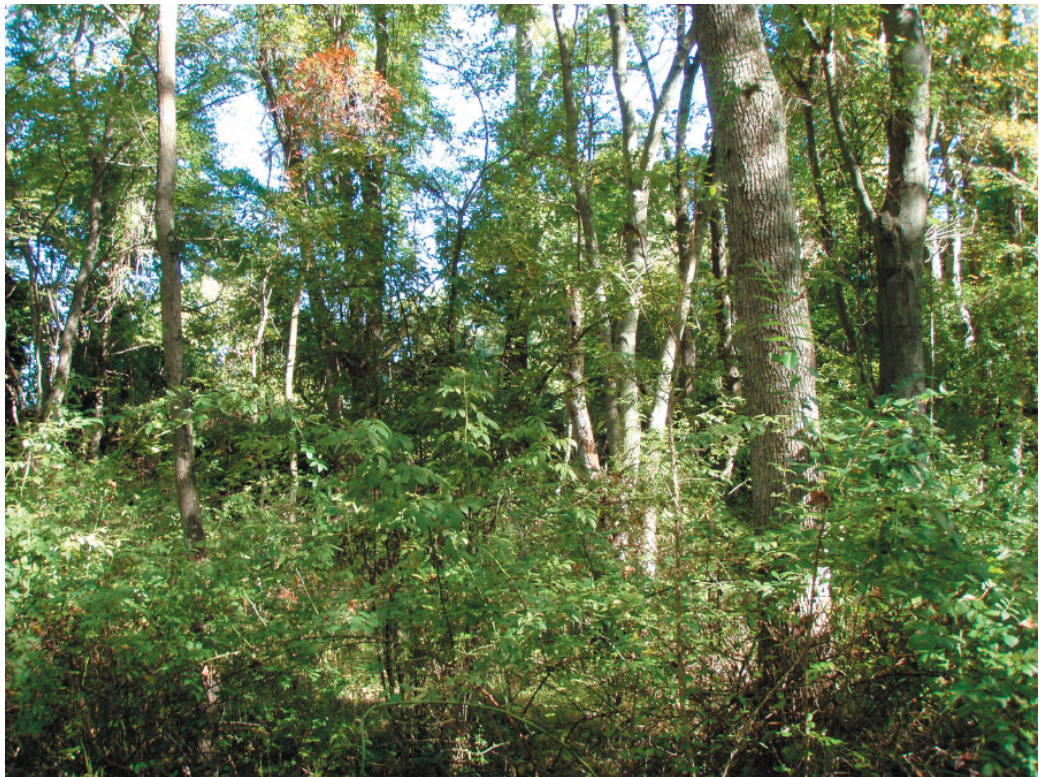
**PHOTO 9: Sycamore-
box-elder floodplain
forest. October 2008.**

4. Sycamore–box-elder floodplain forest (11.5 acres). This community occurs in the floodplain of the Darby Creek west of Route 476 and surrounds pockets of marsh/wet meadow along the riparian corridor (Photo 9). This community is highly variable, containing palustrine and terrestrial areas and significant patches of red maple (palustrine) and sweetgum (*Liquidambar styraciflua*). Dominant canopy species include

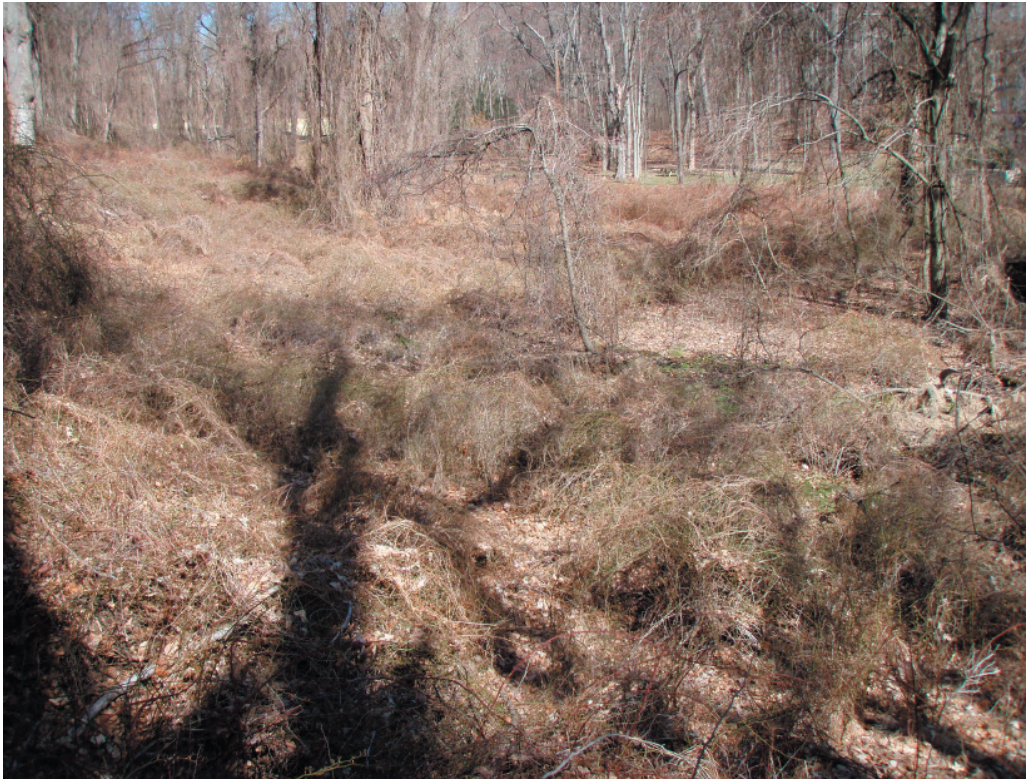
PHOTO 10: Shrubland invaded by multiflora rose. March 2008.

5. Terrestrial shrubland (1.1 acres). A shrubland heavily invaded by multiflora rose is located along the southern border of the property and includes few native plant species aside from a very occasional canopy tree that is structurally compromised by aggressive climbing vines, including porcelain-berry (*Ampelopsis brevipedunculata*), oriental bittersweet and grape (*Vitis* sp.) (Photo 10).

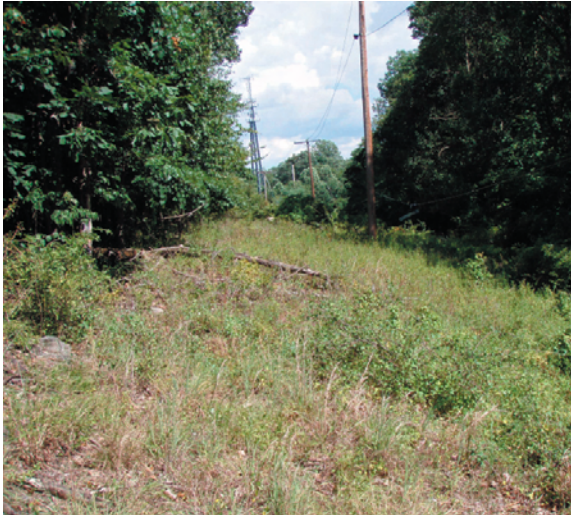
PHOTO 11 (right): Old field / meadow with aspen in background. September 2008.

This open community occurs in three areas on the property: (1) in the middle of the large forest block between North Brook and Darby Road (Photo 11),

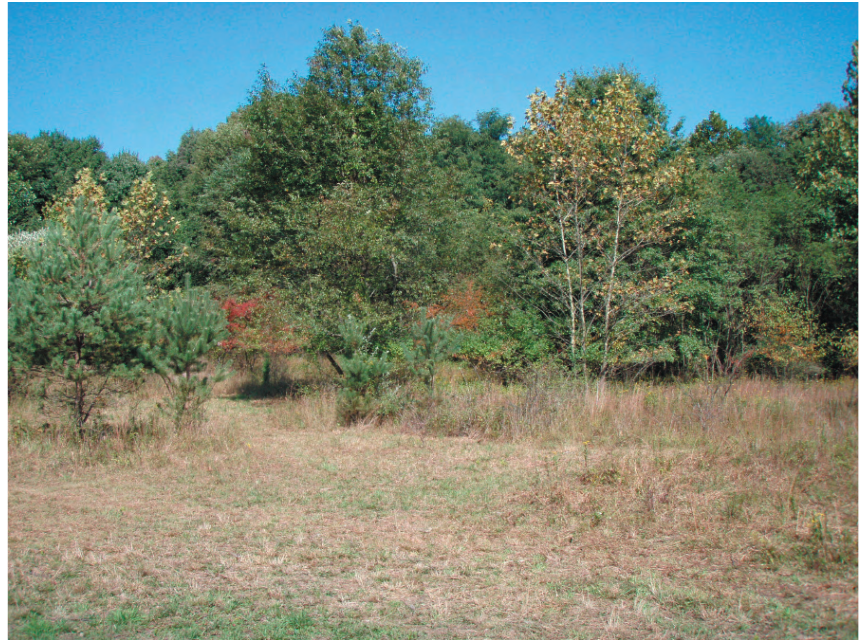
PHOTO 12 (below): Old field/meadow under power line west of Route 476. August 2008.

(2) within the power line and sewer rights-of-way near the northern boundary, and (3) west of Route 476 along a power line right-of-way (Photo 12). This early successional community is dominated by various species of grasses and forbs (see Appendix A for complete listing). The first area (between North Brook and Darby Road), known locally as “The Meadow,” was stripped of topsoil in the development of the Haverford State Hospital several decades ago (see **Map 8: Historical Aerial Photography 1971**), leaving only mineral soil as a substrate for the predominantly native meadow flora that has inhabited the site since that time.

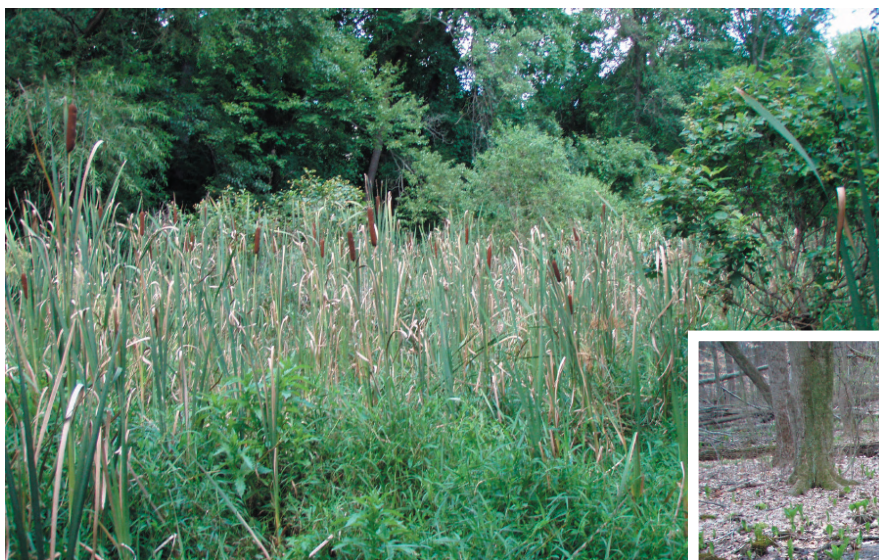
PHOTO 13 (*left*): Marsh/wet meadow west of Route 476. August 2008.

7. Marsh/wet meadow (1.5 acres). Several areas of marsh/wet meadow occur on the property, and include cat-tail marsh (Photo 13) and skunk cabbage (*Symplocarpus foetidus*) forest wetlands along the North and South Brooks (Photo 14). Marsh/wet meadow areas resting within the Sycamore box-elder floodplain forest west of Route 476 along Darby Creek Red contain red maple and scattered willow, with buttonbush (*Cephalanthus occidentalis*), silky dogwood (*Cornus amomum*), swamp rose (*Rosa palustris*), and highbush blueberry

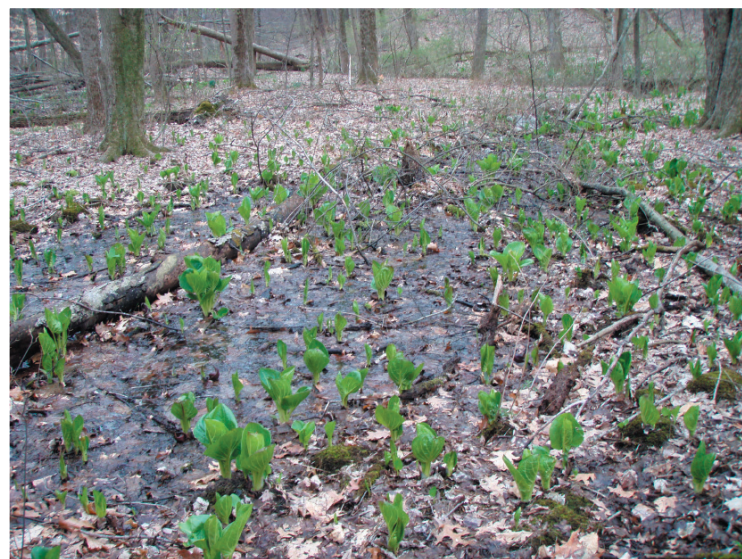
PHOTO 14 (*below*): Skunk cabbage seep. April 2008.

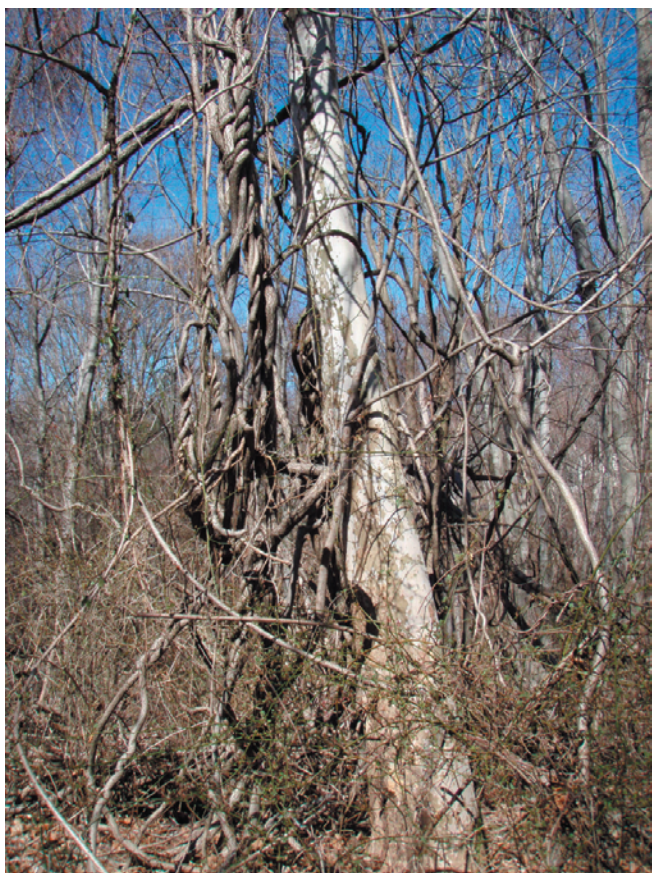
PHOTO 15: Vines (oriental bittersweet) growing up understory trees in high impact invasive area. March 2008.

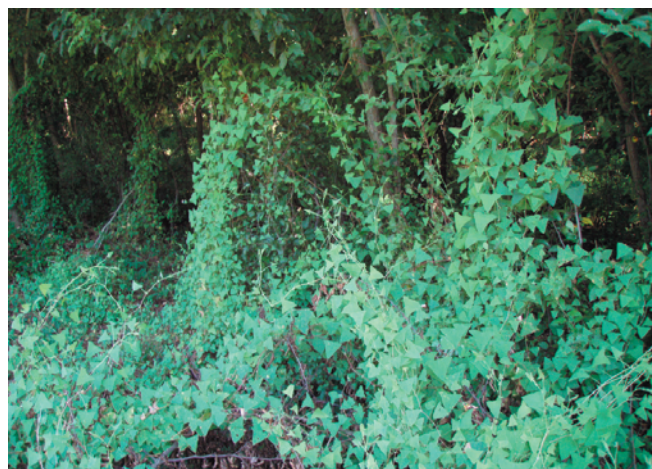
PHOTO 16: The invasive mile-a-minute vine along the edge of red maple terrestrial forest in medium impact invasives area. August 2008.

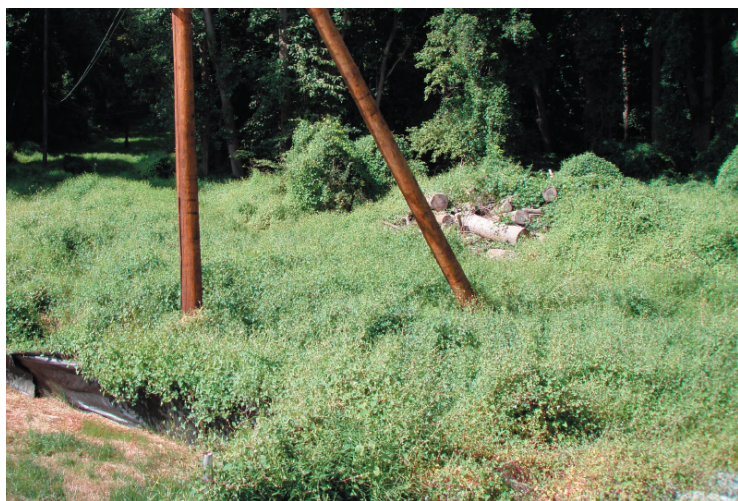
PHOTO 17: High impact invasive area under power line in North Brook section (mile-a-minute, porcelain-berry, and grape vines). August 2008.

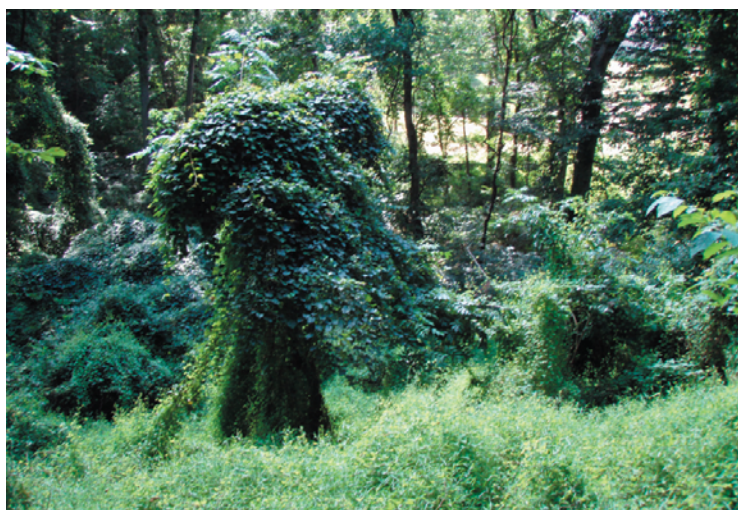
PHOTO 18: Invasive-dominated gap in red oak–mixed hardwood forest. These forests have low invasive impact because invasions are limited to these gap areas. August 2008.

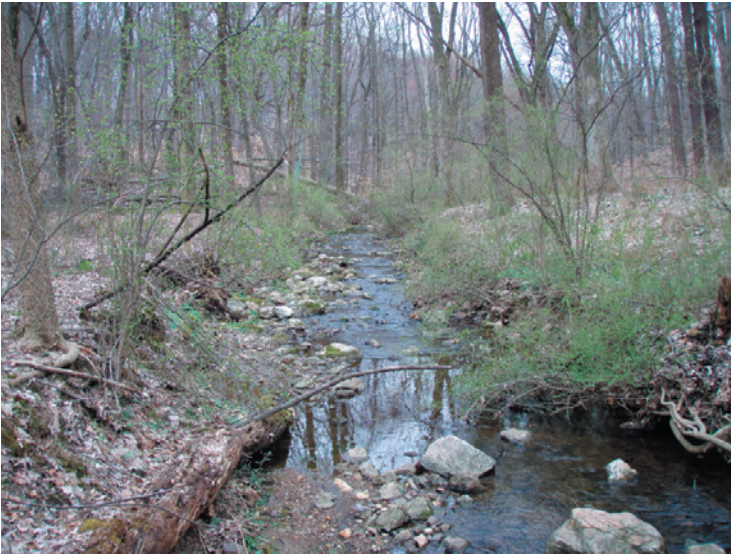
PHOTO 19: North Brook. April 2008.

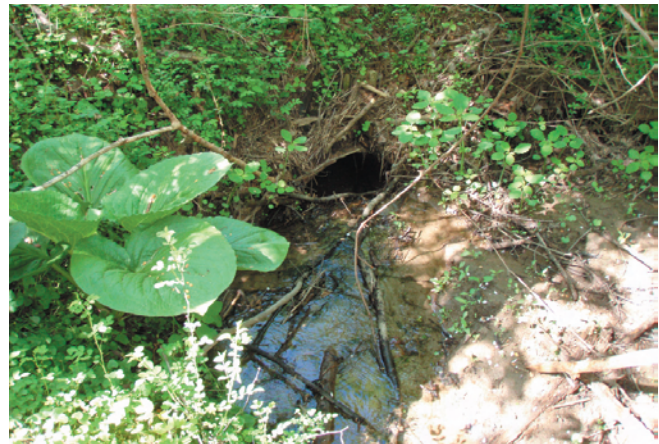
1. **North Brook Upstream.** The upstream station on North Brook bracketed the upper culvert on the stream at the trail crossing (*Photo 20*) extending upstream into the wetland with several sub-samples collected both upstream and downstream of this culvert over a total distance of approximately 250

PHOTO 20: North Brook at trail crossing. May 2008.

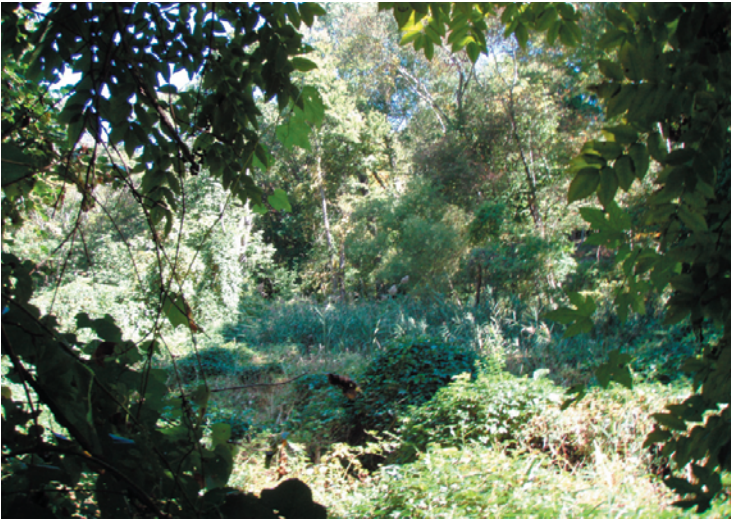
PHOTO 21: Marsh upstream from North Brook Trail culvert. October 2008.

Overall, this site is characterized as moderately impaired because of its high FBI score, indicating the prevalence of pollution tolerant organisms, relatively high percent dominance, and low percent EPT. However, taxa richness and EPT index scored well for this site. Again, these disparities arise because this is a composite sample incorporating widely varying conditions. It must be noted that while the culvert marked a clear delineation in terms of the infaunal community, based on preliminary field observation and variable metric scores, the culvert may in fact benefit downstream community structure as fine sediments seem to be largely trapped upstream of the culvert. Additionally, this area seemed to be more accurately classified as a wetland type of system (marsh) than a riparian one due to flatter topology and more typical wetland vegetation (*Photo 21*).

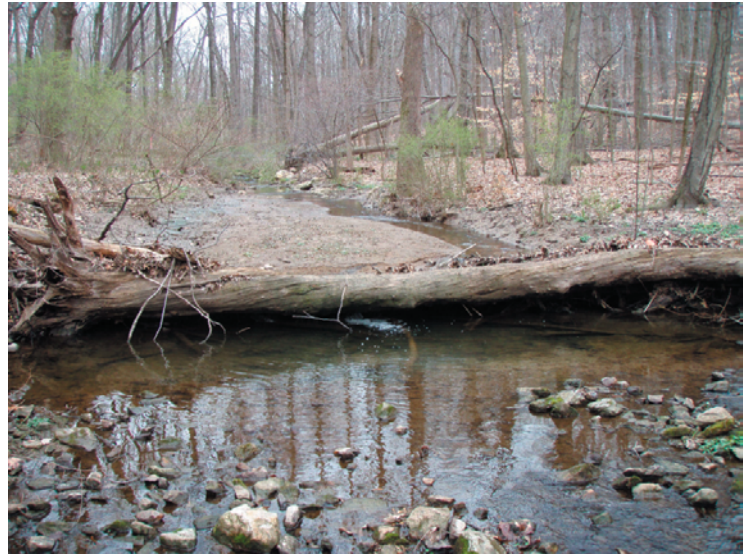
PHOTO 22: Upstream portion of South Brook. April 2008.

South Brook Upstream	
Abundance	226
Taxa Richness	17
EPT Index	6
Percent Dominance	41.15
Percent EPT	51.33
FBI	4.66
Dominant Taxon	Chironomidae

4. South Brook Upstream. The upstream station was located upstream of a newly constructed basin with the upper terminus about 250 meters downstream of Darby Road (*Photo 22*). Sub-samples were collected over a distance of approximately 200 meters. Substrate was very good in this area, characterized by angular cobbles. There was evidence of bank erosion in this reach, which indicates increased hydraulic loading from upstream sources. With the observed erosion in the stream deposition of materials was limited to larger grain sizes such as fine gravels.

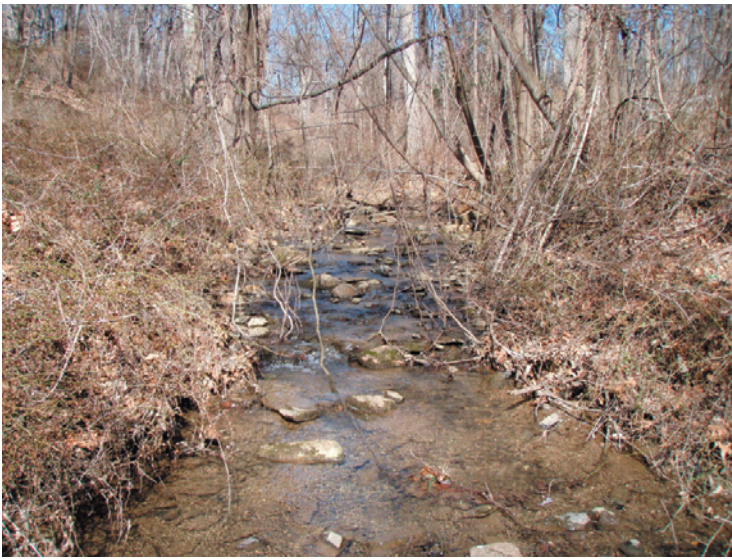
PHOTO 23: Downstream portion of South Brook. March 2008.

South Brook Downstream	
Abundance	137
Taxa Richness	15
EPT Index	5
Percent Dominance	62.04
Percent EPT	22.63
FBI	5.58
Dominant Taxon	Chironomidae

5. South Brook Downstream. The downstream station was limited to the areas between the construction entrance off Darby Creek Road and the semi-breached impoundment upstream (*Photo 23*). This reach was marked by some loss in the quality of habitat with greater density of invasive species, headcuts within the stream, and sediment deposition; however the substrate was generally good. This reach had increased gradient and numerous natural steps and riffles.

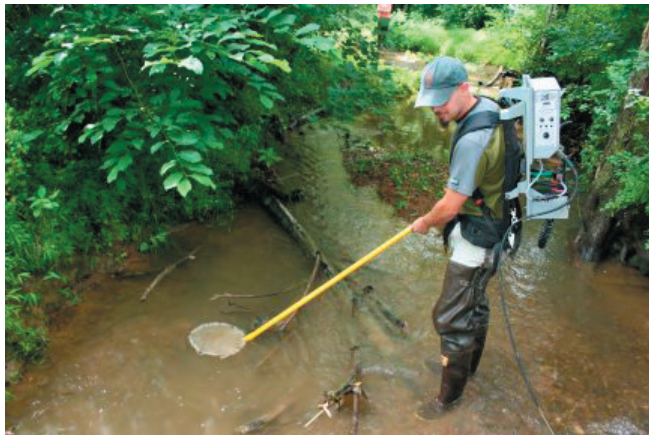
All fish were captured in the survey utilizing stream electrofishing equipment; a non-lethal technique that temporarily stuns fish. Electrofishing is a particularly effective method of capturing fish because it allows targeting on key pieces of structure likely to hold fish and is very effective in shallow stream environments. Fish are immediately captured without the lag of using nets resulting in a much higher catch per unit effort (CPUE). Capture mortality is effectively nil making this a preferred sampling technique from a conservation perspective. Electrofishing involves the use of electrical currents in the water that serve to

temporarily stun fish. When fish enter the electrical fields generated around the electrofishing gear in the water column, the nervous system is shocked and the fish float to the surface for capture. Larger fish often involuntarily orient themselves in the electric field and actually move towards the source of the stimulus. The size of the electrical field generated in the water is dependent on a variety of parameters, most importantly water temperature and conductivity, but for the most part is confined to immediately between the electrode probes.

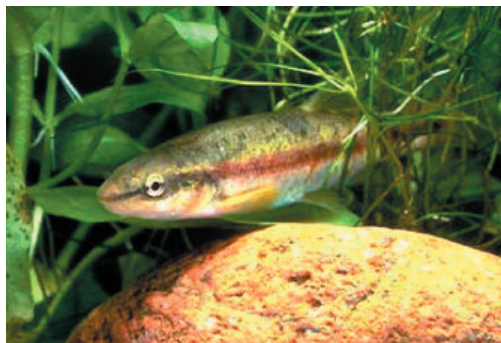
Blacknose Dace

Creek Chubs (*Semotilus atromaculatus*) and White Suckers (*Catostomus commersoni*) were also important components (Figures 1 and 2). For the most part the fishery consisted of small species, with all species averaging less than 6 inches in total length with the exception of American Eel (*Anguilla rostrata*) and Rock Bass (*Ambloplites rupestris*) (Figure 3).

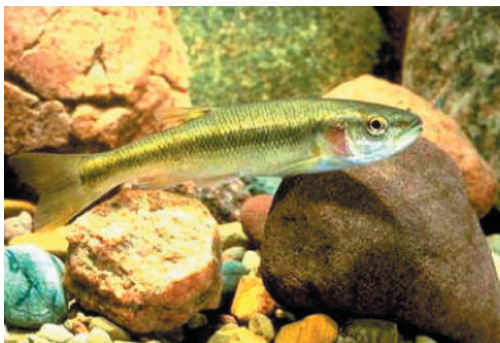
Creek Chub

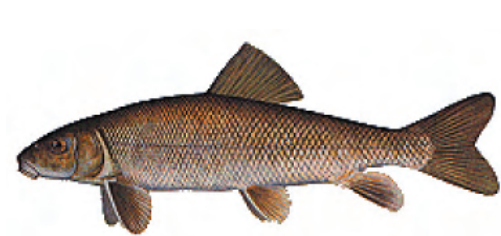
White Sucker

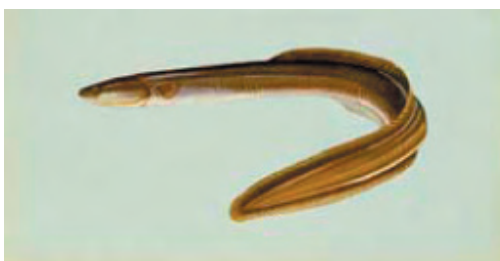
American Eel

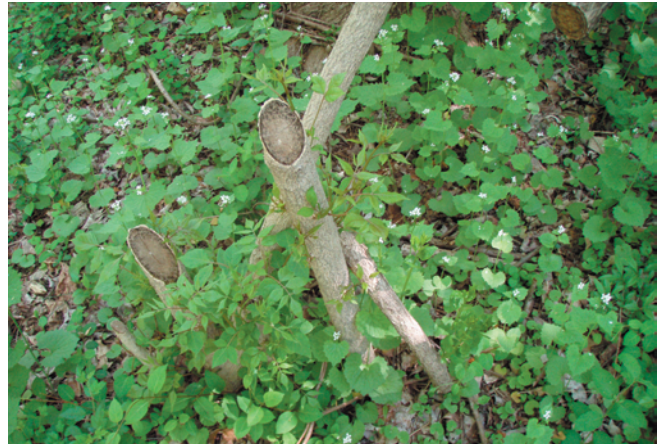
PHOTO 24: Corktree resprouting with second-year flowering garlic mustard. May 2008.

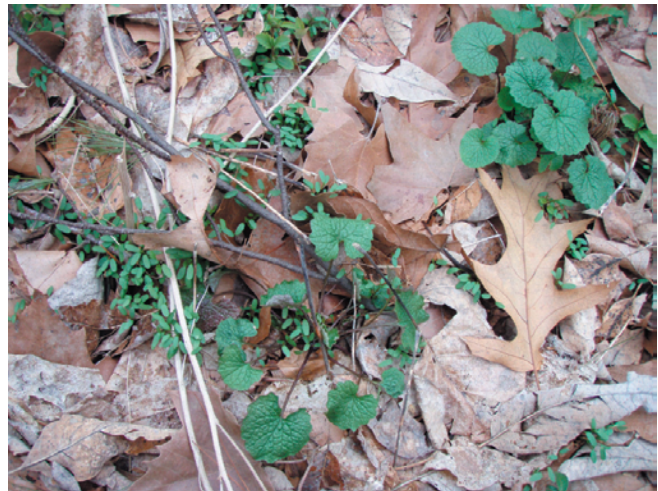
PHOTO 25: Garlic mustard (first-year leaves) and Japanese stiltgrass on forest floor. April 2008.

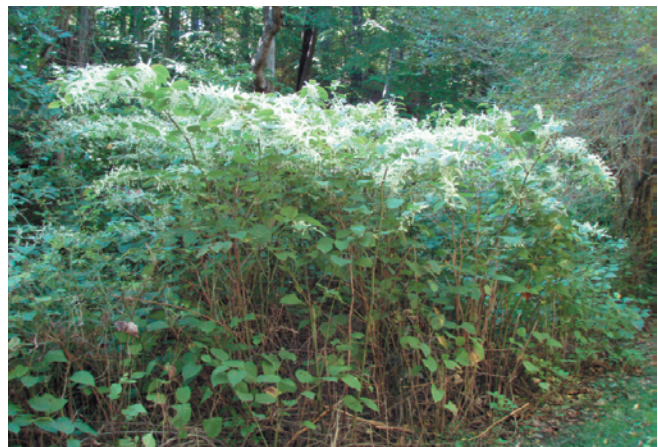
PHOTO 26: Japanese knotweed along Darby Creek. October 2008.

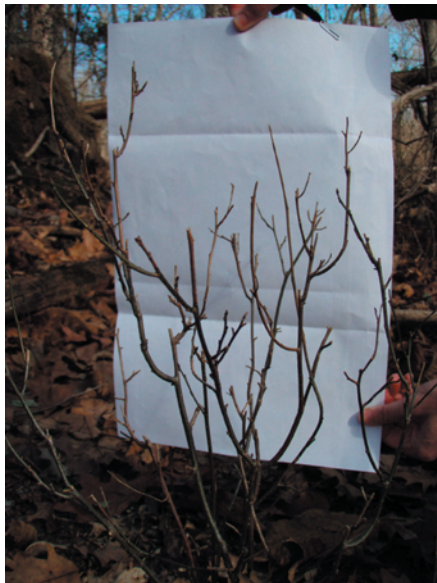
Deer are browsers, which means their diet consists mainly of newly grown twigs of woody plants, primarily trees and shrubs. When populations are high, deer can consume all of the established seedlings, as well as many tree seeds (particularly acorns) and herbaceous plants. Over 100 species of native wildflowers and other plant species have been extirpated from Pennsylvania; at least some of these losses have been partly a result of overbrowsing by deer, and many more species are known to be in trouble in the state from the same cause. Browsing by overabundant deer dramatically reduces the survival of native flora and has led to the collapse of plant species diversity in the forest understory and the near cessation of tree reproduction in vast areas of Pennsylvania forests. The resulting lack of cover, food, and structural diversity within forests has undoubtedly reduced wildlife populations, particularly of small mammal and bird species. Native oaks, which are highly preferred food for deer, are not regenerating, which means that wildlife-rich oak forests will cease to exist as adult trees age and die. Furthermore, exotic (non-native) invasive plant species are generally avoided by deer and other plant-eating wildlife (which is one of the reasons they are invasive), so deer have contributed to their proliferation by stripping the forests of their native competitors. The elimination of tree regeneration not only removes the defining component of the future forest (canopy trees), it greatly amplifies the effects of other stressors by freeing up growing space to invasive plant species and

PHOTO 27 (right):
Evidence of deer
browsing in shrub
layer of forest.
January 2008.

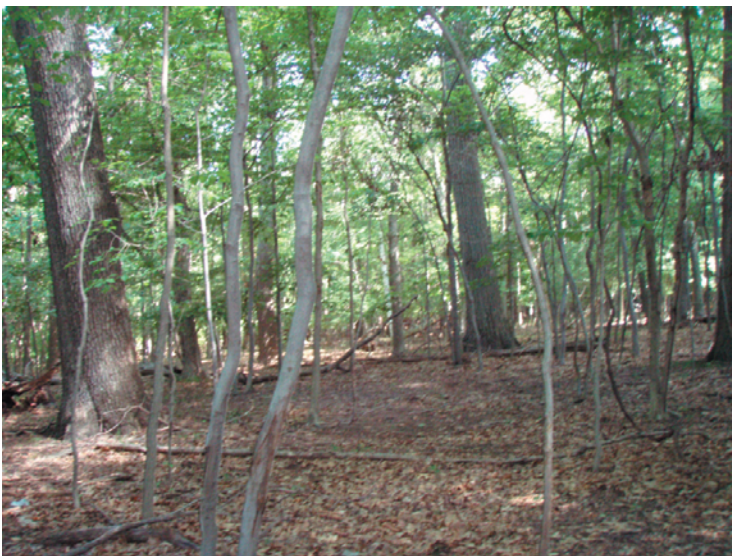
PHOTO 28 (below):
Prominent browse
line in red oak
mixed hardwood
forest. August 2008.

superficially healthy because they are green. Forests with an understory stripped of vegetation have a park-like structure, with tall canopy trees and a uniform low understory or no understory at all. Forests in some parts of our region have looked like this for so long that many people have the impression it is normal and natural.

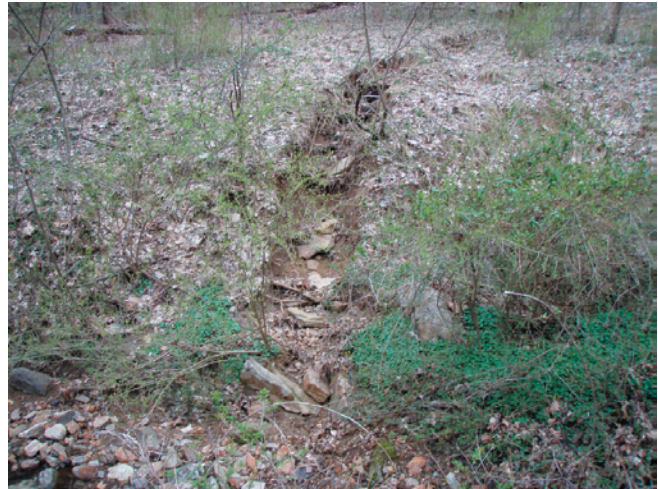
from the developed area into the surrounding natural areas. One of these channels drains to the south toward South Brook (*Photo 30*) and the second drains to the north into the red

PHOTO 29: End of stormwater channel from Quadrangle parking area, as it enters South Brook. April 2008.

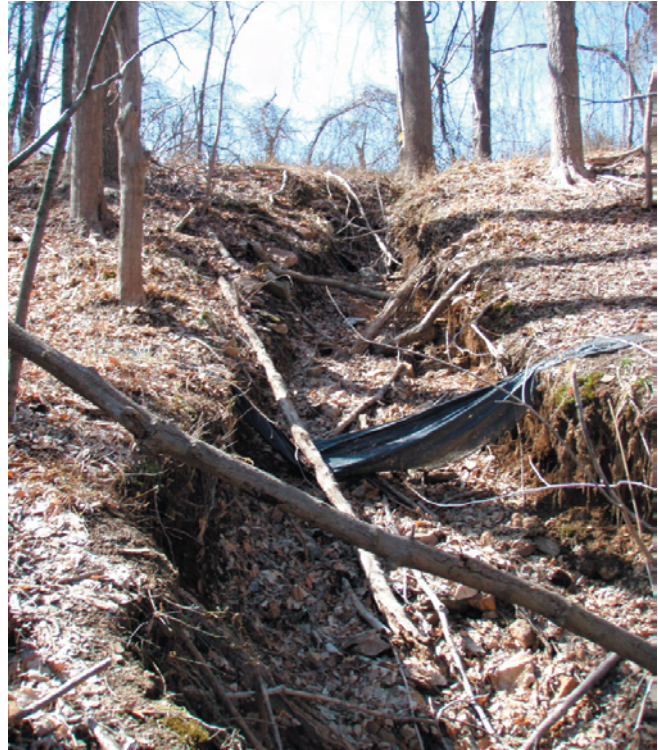
PHOTO 30: Drainage channel coming from construction site bringing water to the south. March 2008.

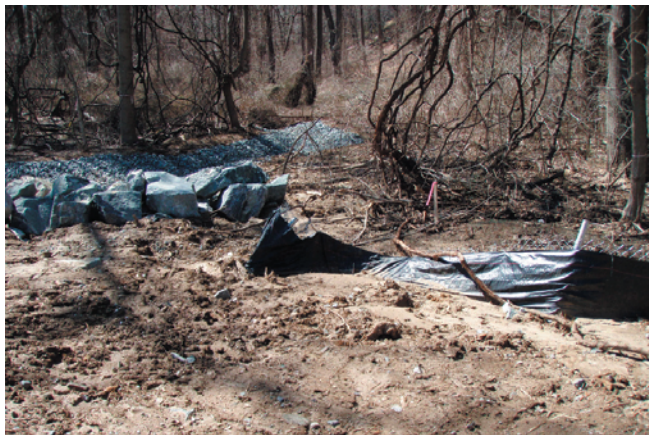
3. At the time of our spring site visit, the drainage from the detention basin near the northeastern construction entrance (Darby Road) was bypassing the silt fencing that has been damaged by excess flow (*Photo 31*). This presents a concern in terms of the effect of the outflow on the pH and siltation levels of North Brook. Water quality in this first order stream will affect downstream conditions in the watershed.

PHOTO 31: Drainage bypassing silt fencing near northeastern construction entrance, Darby Road. March 2008.

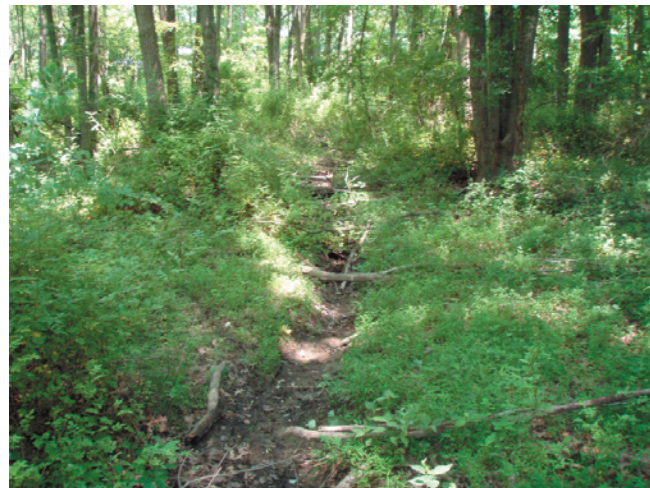
PHOTO 32: Gully erosion from drainage from damaged culvert under Route 476. June 2008.

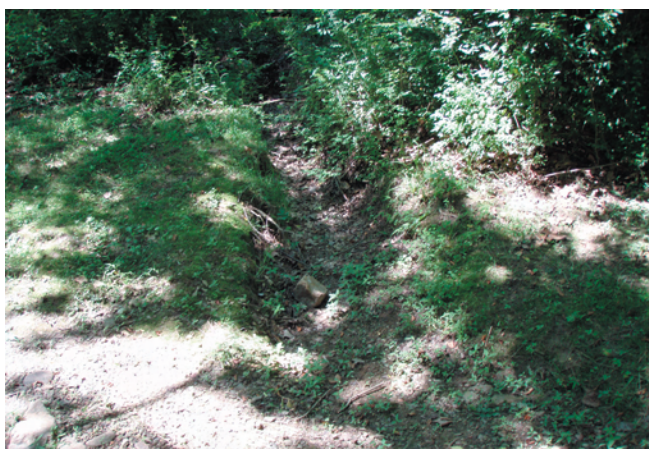
PHOTO 33: Gully erosion from road running through floodplain forest. June 2008.

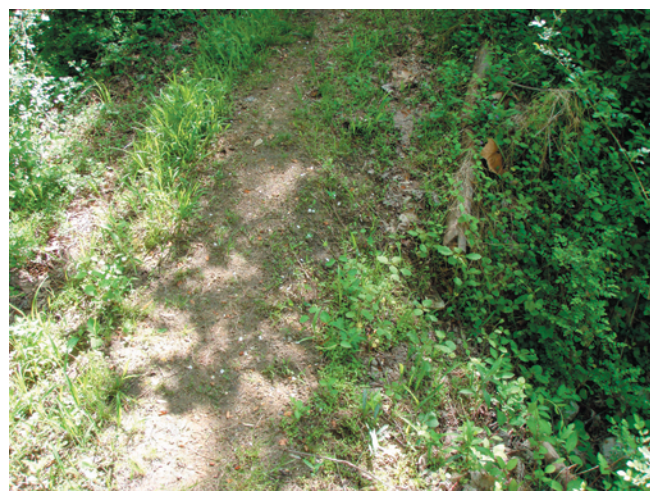
PHOTO 34: Partially blocked culvert along North Brook and road erosion likely due to excessive stormwater flows. May 2008.

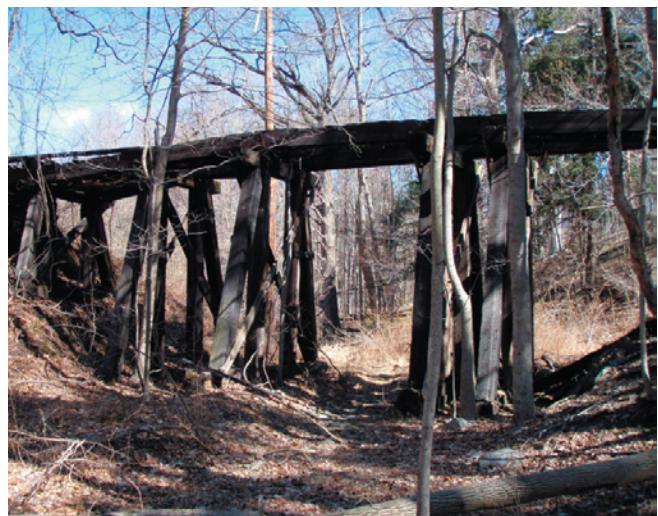
Several hazards were noted in our surveys and these are labeled on **Map 11: Stewardship Issues and Opportunities**. Of greatest concern is the old railroad bridge in the Darby Creek parcel west of Route 476 (*Photo 35*). This is an attractive nuisance that should be addressed as soon as possible. Other potential hazards include the remains of the old dam along South Brook (*Photo 36, page 44*), a remnant brick chimney south of the construction site (*Photo 37, page 44*), old barbed wire fencing near the northeastern detention basin, and the remains of a ropes course in the area of the meadow (*Photo 38, page 44*) and North Brook. We also noted potential hazard trees near construction areas. With the upheaval and disturbance of soils, root systems of nearby trees are

PHOTO 35: Old railroad bridge as a hazard. March 2008.

- Remove attractive nuisances from the property before it is open to public use, including the old railroad bridge west of Route 476, the old dam on South Brook, the brick wall south of construction site, barbed wire fencing, and the remains of the ropes course.
- Conduct an assessment of hazard trees near areas of potential public use and address trees that pose a danger to visitors. Monitor hazard trees by foot once each year and following severe storms. Ideally, a certified arborist should be hired to complete this task and address any identified hazards through pruning or removal.

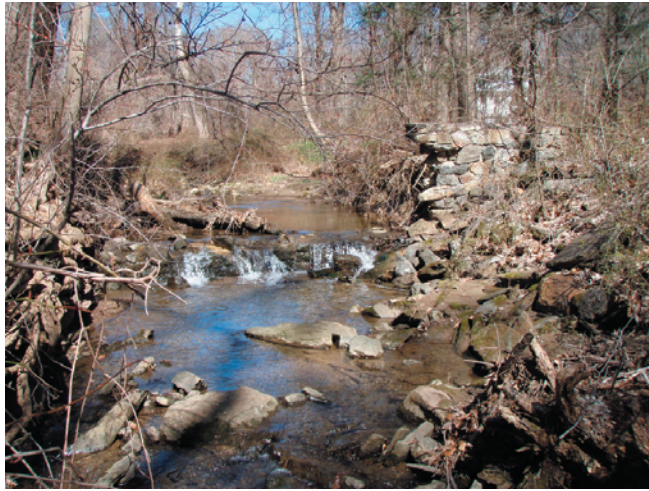
PHOTO 36: Remains of an old dam along South Brook. March 2008.

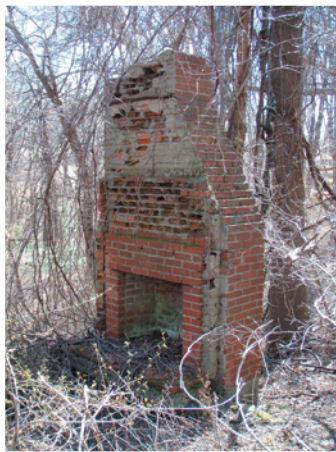
PHOTO 37 (left): Remains of a brick chimney in South Brook section of project area. March 2008.

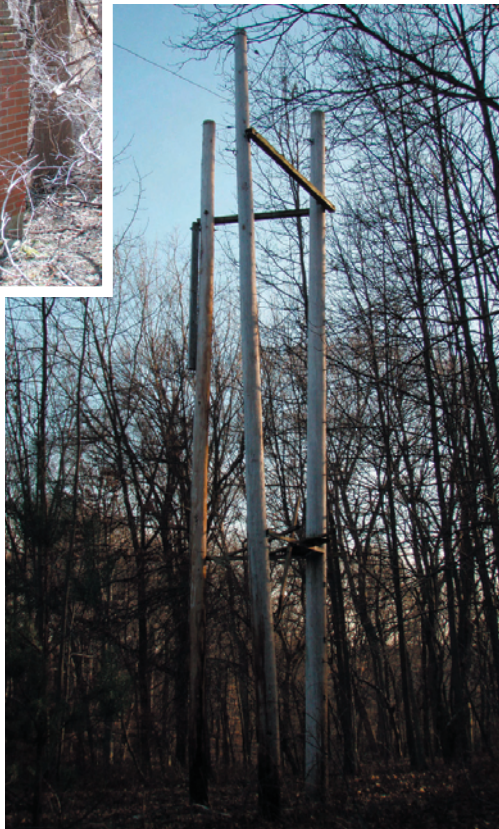
PHOTO 38: Remains of ropes course posing a potential hazard. January 2008.

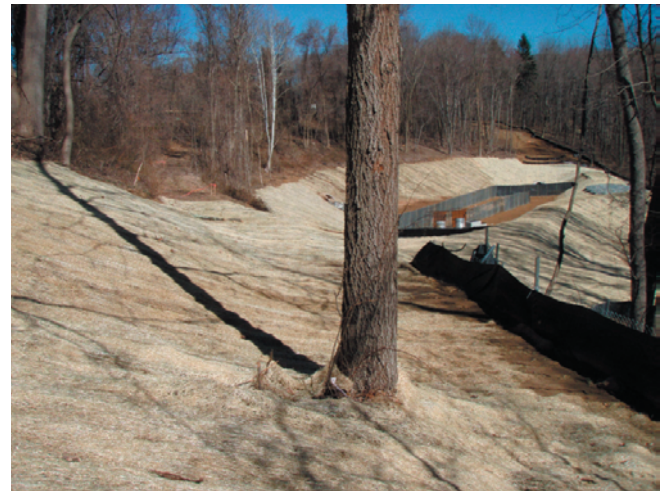
PHOTO 39: Potential hazard tree that may have been weakened by nearby construction activity. March 2008.

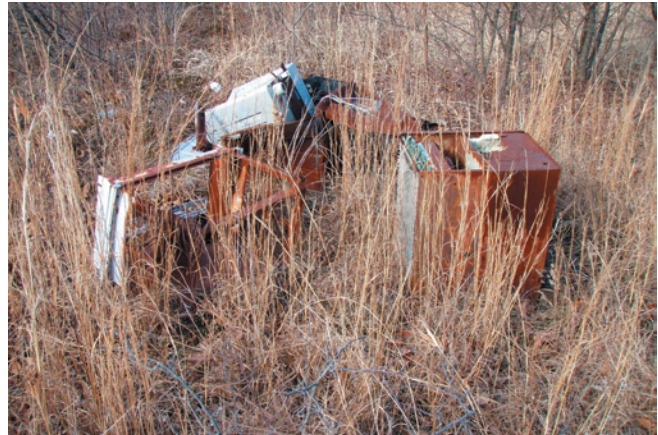
PHOTO 40: Old air conditioners in old field/meadow of North Brook section. January 2008.
